JANUARY 1994

Improved Resealing Procedures for the Second Deseal/Reseal Program in RAAF F111 Aircraft Fuel Tanks

MRL Technical Report
MRL-TR-93-64

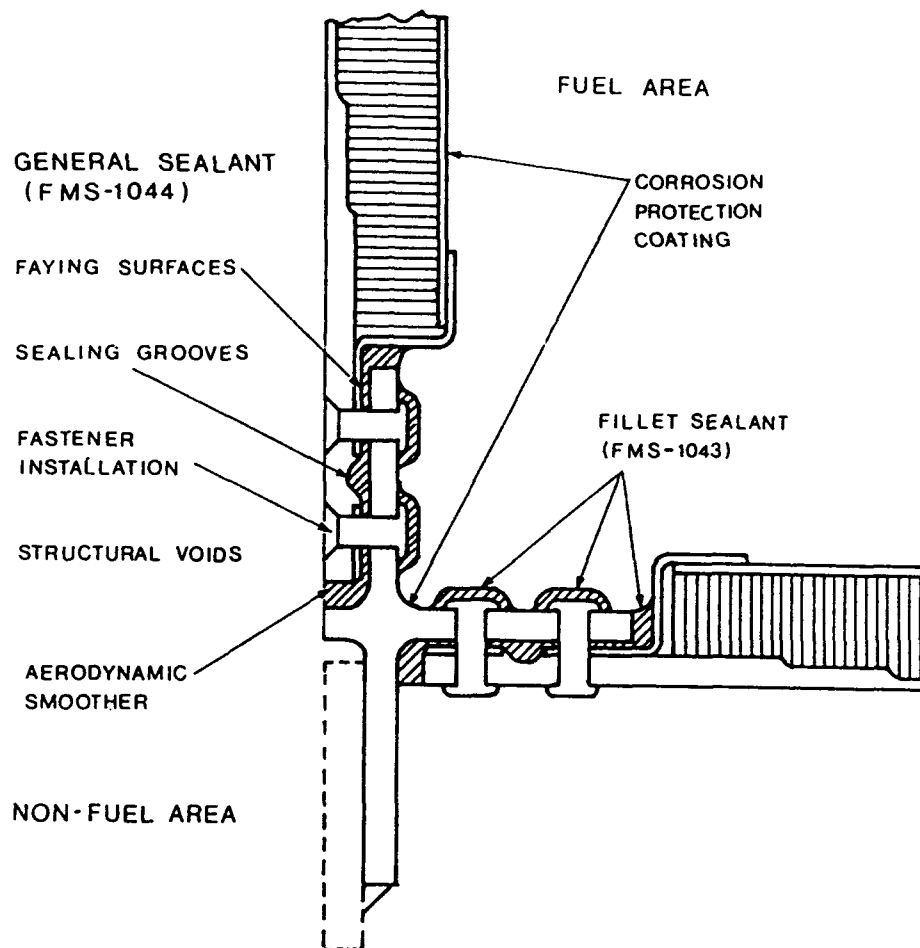
The polyester sealant (ii) was originally selected for use because of its excellent high temperature properties. However, its susceptibility to hydrolytic breakdown was never examined and, as a result of this shortcoming, extensive fuel leaks occurred in RAAF and USAF aircraft after a relatively short period of time. As a consequence of the polyester breakdown, all RAAF F111 aircraft underwent an extensive deseal/reseal program between 1977 and 1982. To augment the resistance of the polysulfide sealant to penetration caused by expansion of the hydrolysing polyester [1,2], a relatively rigid epoxy polyamide material was applied across all gaps as a supplementary barrier. Polysulfide was then applied over the epoxy barrier coating to protect it from aviation turbine fuel and fuel additives.

Figure 1: Original sealant system employed in F111 fuselage fuel tanks.
